November
2014

CONCRETE CONNECTIONS

- Presidents report 2014
- ACRA Awards – the winners....
- Want to join an ACRA Sub Branch Committee?
- Come along to one of our Xmas drinks
- Managing the durability of existing assets by AECOM
- Project Profile by Max Build
- Concrete Spalling
- Corrosion & Protection course
- Meet your new ACRA Board Members 2014-2015
- Meet our new members
- Introducing the New Concrete Crack Repair Range - Ardex

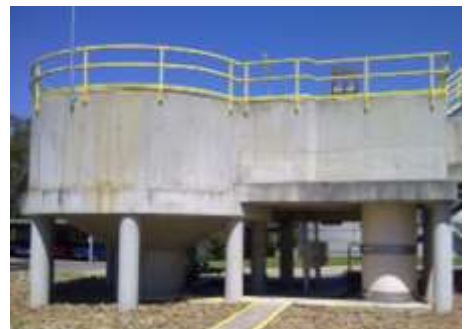
“The Penrith ST0046 Water Recycling Plant is owned and operated by Sydney Water and located on Castlereagh Rd, Penrith. SASTTI Joint Venture was engaged by Sydney Water to carry out an inspection and condition assessment of the Inlet Works, Grit Removal Tank and Flow Distribution Chamber. It was identified that the grit removal area has exposed concrete surfaces which are

experiencing up to 30mm of biogenic acid attack and in the flow distribution chamber areas generally lost 55 mm of concrete cover. This required urgent repairs to both the Grit Removal Tank and the Flow Distribution Chamber to ensure the structural integrity on these critical operational assets.

The access to both the grit removal vortex and the flow distribution chamber was difficult and required substantial and complex scaffolding structure to provide a safe working area and access & egress. Additionally the configuration and size of the structures made it very onerous to complete the repairs.

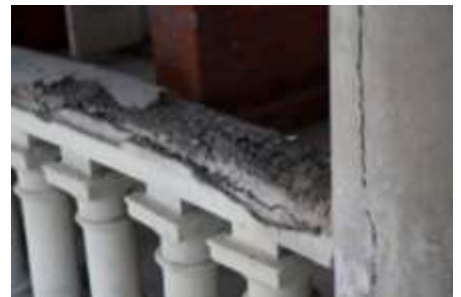
Well-developed cracking was evident on the balcony corbels, convex spandrel beam, floor slabs, longitudinal and transverse beams and columns. Slight structure movement over time had caused cracking of the outer cementitious encasement allowing the ingress of moisture and carbon dioxide. This resulted in sections of the coke breeze concrete becoming carbonated and the pH lowering to a level that supported steel corrosion.

In addition many of the ornate heritage architectural features were cracked, damaged or broken off completely. Two handrails were completely destroyed as a consequence of building settlement. Fortunately in all cases there were sufficient undamaged features to enable accurate moulding, and recasting to be performed using similar cementitious materials and traditional methods.

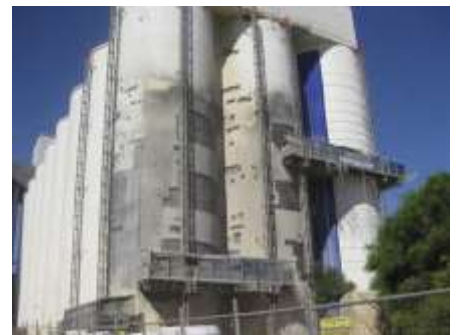
As is typically found for circular grain storage facilities of this type and age, it was concluded that the original design understanding was inadequate to cater for the peak loads occurring during grain outflow. The resulting structural cracking reflected this structural inadequacy, and given the marine environment in which the silos are located, also raised concern in regard to the long term durability of this structure.

After failed remedial works, Freyssinet were called upon to provide a complete design & construction solution. With a history of similar strengthen & repair projects throughout Europe & the Middle East, Freyssinet not only executed the project allowing the terminal to continue operating without significant loss of capacity, but the overall finished product is set to provide an additional 40 years service life.

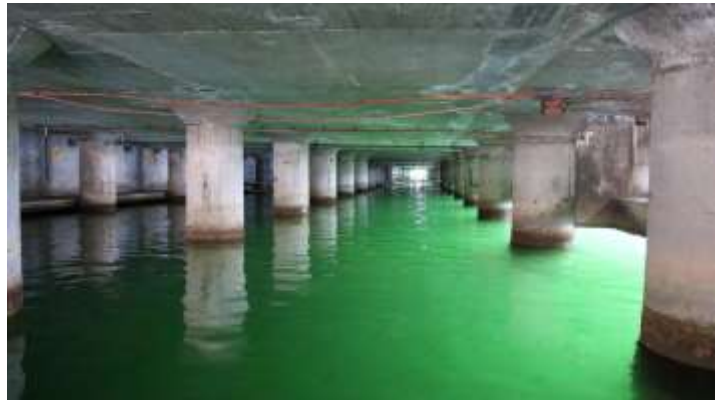
consist of conventionally reinforced two-way spanning concrete suspended decks 184m long x 15.8m wide (Berth 1) and 16.6m wide (Berth 2), supported by three rows of 1067mm diameter reinforced concrete piles which have been installed within a rock protected embankment forming a conventional 'land back' berth system. The piles are 'pin' supported onto the Bunbury Basalt formation. The height of the deck is 3.6 metres above datum level. Given the berth age is in the order of 40 years, it has exceeded the original theoretical design life hence requiring appropriate levels of management including consideration of future berth plans, condition assessment and maintenance repair efforts. The repair of berths (1 & 2) will take place over a staged five year design and construct maintenance contract, broken down into repairs to piles, approach slab subsidence, general concrete, steelwork and joint repairs to Berths 1 and 2, with Berth 2 piles and approach slabs taking priority.

The Berth 2 piles, particularly through the inter-tidal and splash zone above low water, are suffering from varying degrees of deterioration including significant cracking, delamination of cover concrete and in one case; fully exposed rebar where total spalling loss of the cover concrete has occurred. The approach slabs and hardstand to the rear of the Berth 2 deck are also suffering varying degrees of subsidence requiring remediation for safe use of the berth.

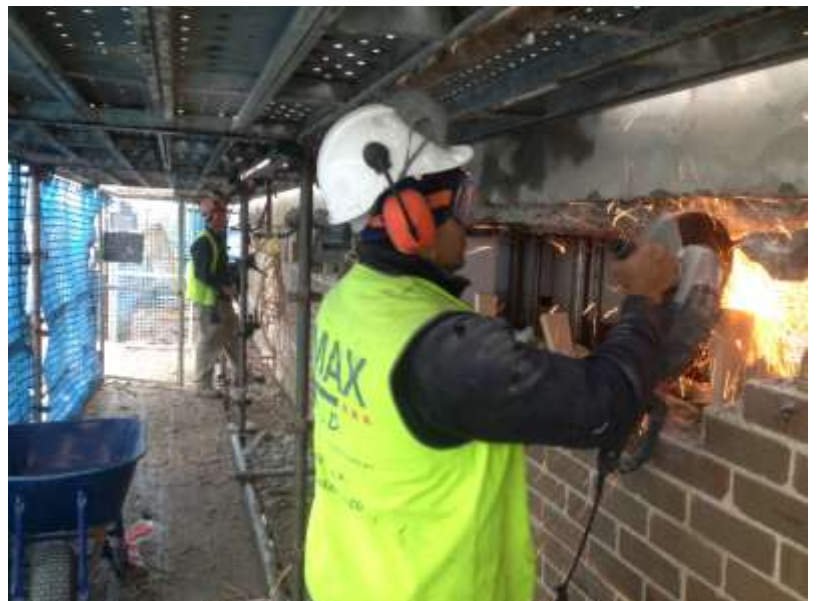
Aside from the quality of the original steel reinforcement, MAX Build's team discovered over the course of the six-month project that all other materials and building processes were substandard when contrasted with today's techniques. If the original builders had known what we do, a sizable component of the concrete spalling and cancer could have been prevented.

The distribution of aggregates, along with sand and slurry was also overlooked. From what MAX Build exposed, the original mix needed a bit longer in the mixer and a stir once settled in the formwork.

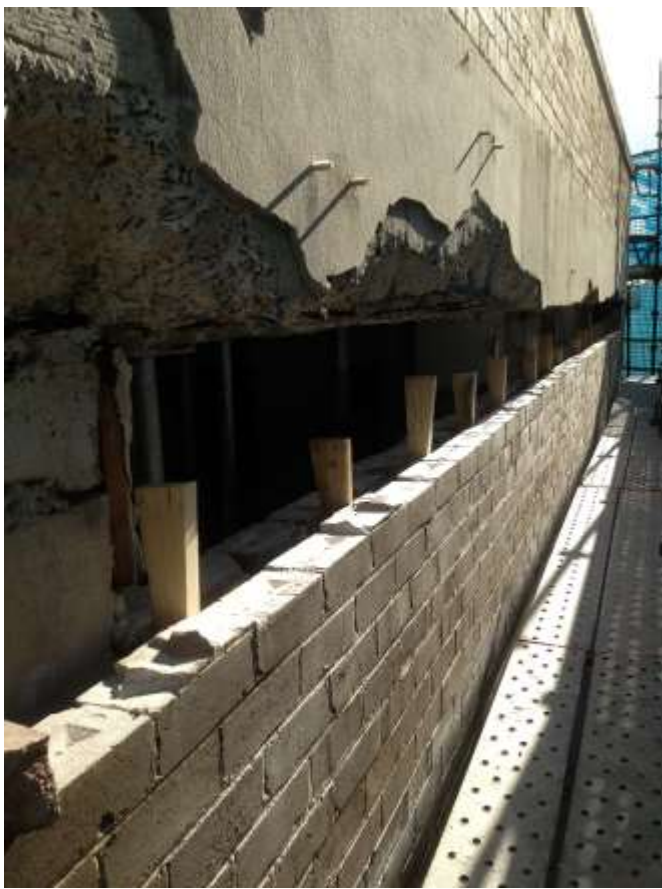
For Wright, the stand out on this repair was working with the coke-breeze concrete, which is “weak and porous as was typical during that era of construction in the 1920s”. It allowed for the easier passage of chlorides to the steel reinforcement. Coke-breeze concrete was also used on the Sydney Harbour Bridge. “And it’s still standing!” adds Wright.

The placement of the concrete was also below current standards with large concentrations of air holes apparent on the surface and honeycombing on the corners, reducing the concrete’s strength. We would today construct formwork tight enough to prevent leeching during the pour, and set period so that cement isn’t carried out of the form with any water run-off. Also the concrete is mechanically compacted to remove any air holes and ensure a dense, tight-packed concrete around any reinforcement bar.

All of the reinforcing that was corroding and spalling the concrete, was too close to the surface, this allowed moisture and air to start the corrosion process that then self-perpetuated until all recognisable strength from the steel was lost. Today we would employ plastic bar chairs or wagon wheels to hold the reinforcement in a minimum distance from the concrete surface, especially during the initial moments when the force of pouring concrete can move the steel cages.
