CONCRETE CONNECTIONS

The Challenge of Deteriorating Water Assets

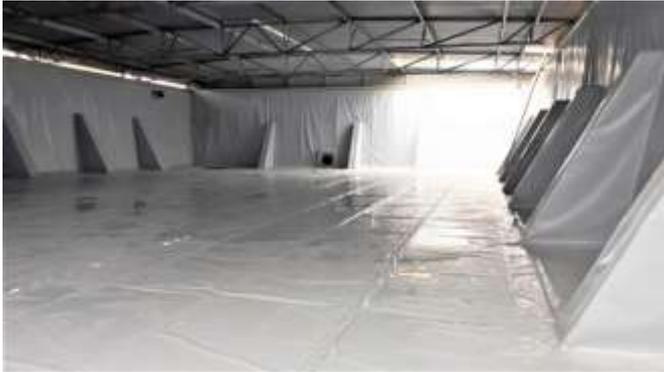
For over a century, Wallis Hill Clear Water Storage tank has provided potable water to the town of Seymour. In December 2018, Goulburn Valley Water awarded MCM the contract to rehabilitate the tank's concrete substrate and replace the tank's liner to prolong its service life.

MCM has completed concrete patch repairs and crack injection repairs using a hydrophilic polyurethane-based product. Failed joint sealant around the perimeter of the tank has also been removed and replaced. A reinforced ethylene interpolymer alloy was installed over all submerged interior surfaces, using a novel approach.

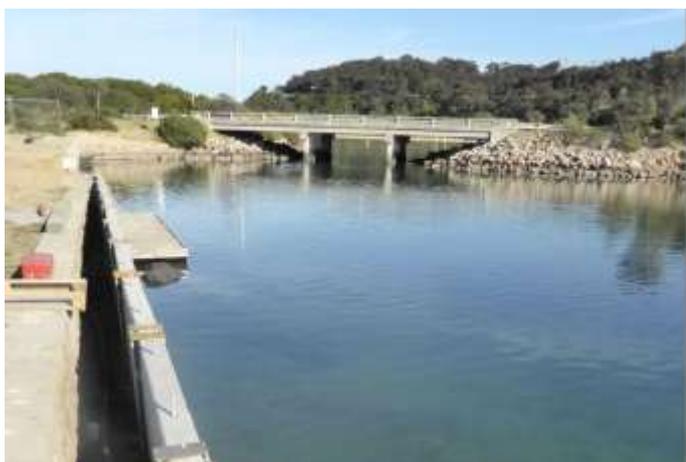
Gippsland Ports is continuing works to shore up the Narrows seawall on the eastern side of Bullock Island with funding from the Victorian Government's \$15 million Protecting Victoria's Iconic Beaches and Coasts Program.

Stage 2 will involve the installation of 80m of pre-formed concrete panelling, and when completed, the old unstable masonry rock seawall will be replaced with a precast concrete panel structure.

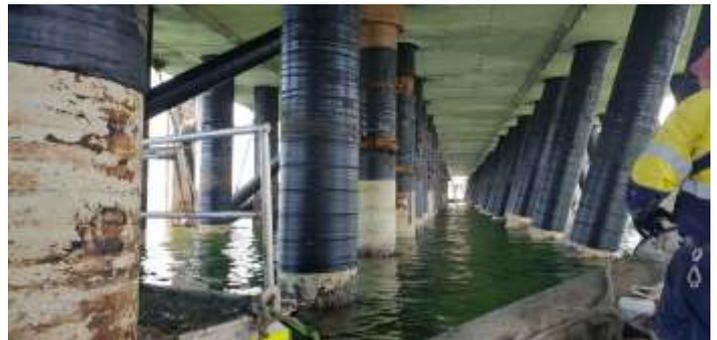
To significantly extend the wharves' service life, we repaired the existing pile wrapping system, applied a new silane coating to the wharf deck, soffit and concrete fender panels. We also performed concrete repair and installed sacrificial anodes.

Photo: Completed pile wrapping system repair

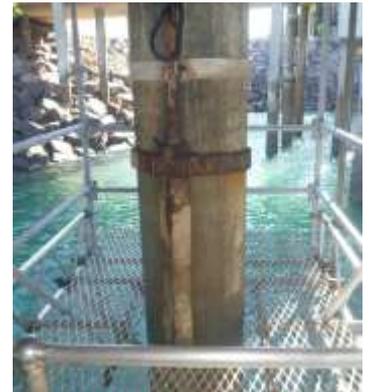
Photo: Work platform around concrete piles to complete crack and spalling repairs

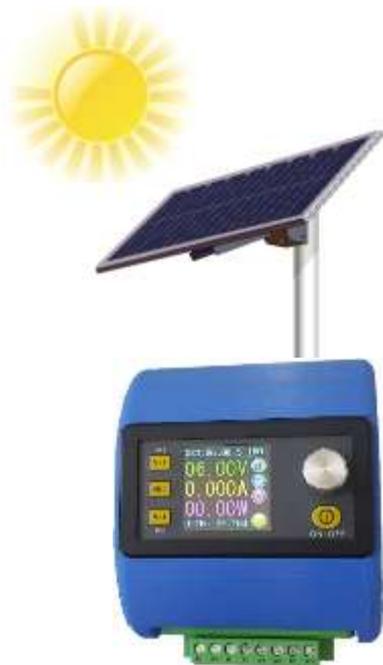
MicroNex – Solar PS

In the past year, Remedial Technology's R&D division has developed a simple, reliable and heavy-duty solar powered unit which can provide cathodic protection current to reinforced concrete structures. The primary advantage of this new innovation is its ability to be installed in remote locations, its minimal monitoring and maintenance requirements and its capacity to achieve optimum corrosion protection based on the current Australian Standard for steel in concrete (AS 2832.5 – 2008). The commercialisation of this technology is expected late 2019.

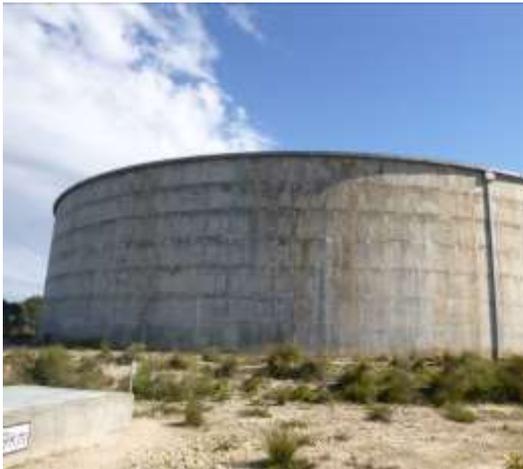
The common tank design employed by SA Water is an in situ cast concrete floor with a ring beam, in situ cast concrete walls and a galvanized steel sheeting roof (Figure 1), with a galvanized steel roof support structure supported by concrete columns within the tank (Figure 2). Some of the columns were precast but the majority were cast in situ.

Figure 1 External view of a typical concrete tank

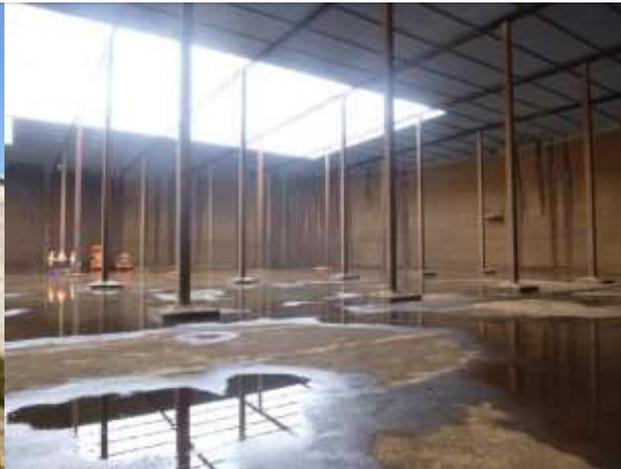
Figure 2 Internal view of a concrete tank with columns
(roof partially removed)

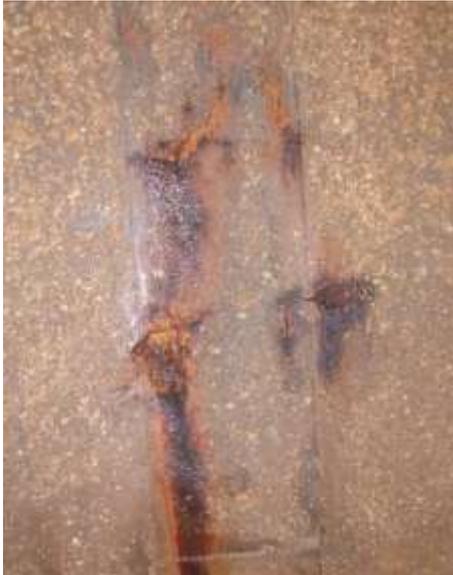
Two instances of severe corrosion of reinforcement had occurred as shown in Figures 5 and 6. These areas had suffered localised severe pitting and metal loss. In both cases the concrete appeared to have been poorly compacted which may have contributed to severe corrosion in these locations, whereas nearby areas

Figure 5 Visual appearance of concrete surface with evidence of steel reinforcement corrosion within the wall

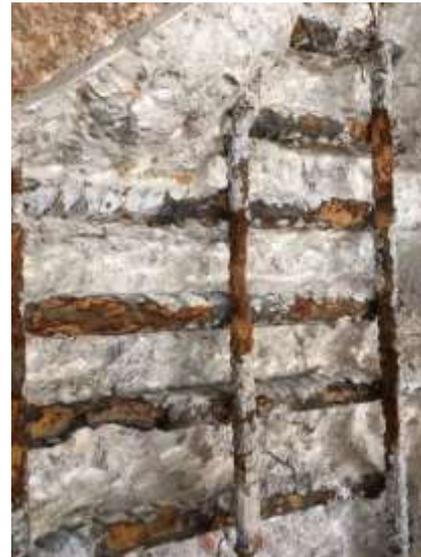
Figure 6 Reinforcement condition of the area identified in Figure 5 after concrete was broken away

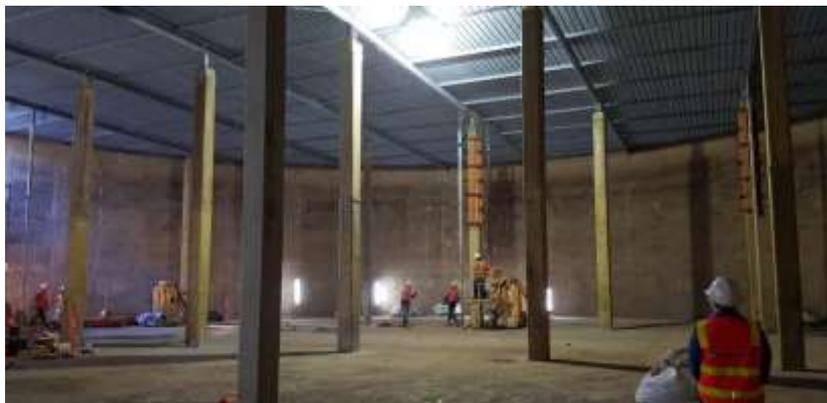
Initially, it was planned to construct conventional formwork and pour additional material at the top of the column. This presented construction issues due to working at heights and created significant weight at the top of the column which was undesirable from a structural perspective. Industry feedback led to designs that incorporated fibreglass jackets as formwork. These jackets could be stacked for the full height of the column, filled with grout and create a new larger column, Figure 7.

Figure 7 Columns rehabilitated with fibreglass jackets

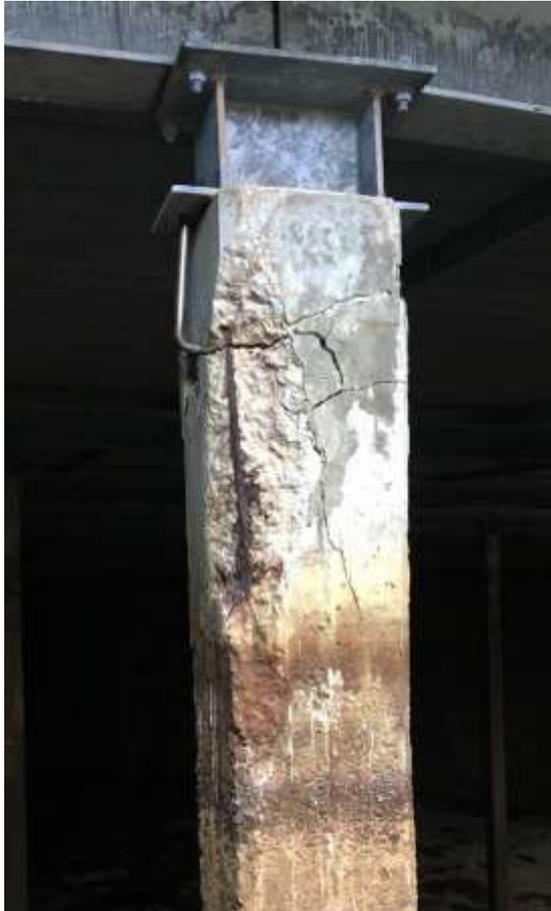
during concrete pouring or movement of the formwork during concrete pouring. Note also that the 25mm chamfer on the corners of the column reduces cover on the corners. Corners have increased susceptibility to corrosion as the edges receive a contribution from each of the two sides. As a result, carbonation of the concrete can lead to low pH at the reinforcement and subsequent corrosion of the reinforcement for the columns earlier than the internal walls that have a much higher thickness of concrete cover. It was assumed that the carbonation was due to the exposure to air in the air space above the water level inside the tank⁹.

Figure 9 Top of column showing corroded reinforcement with low cover and concrete cracking

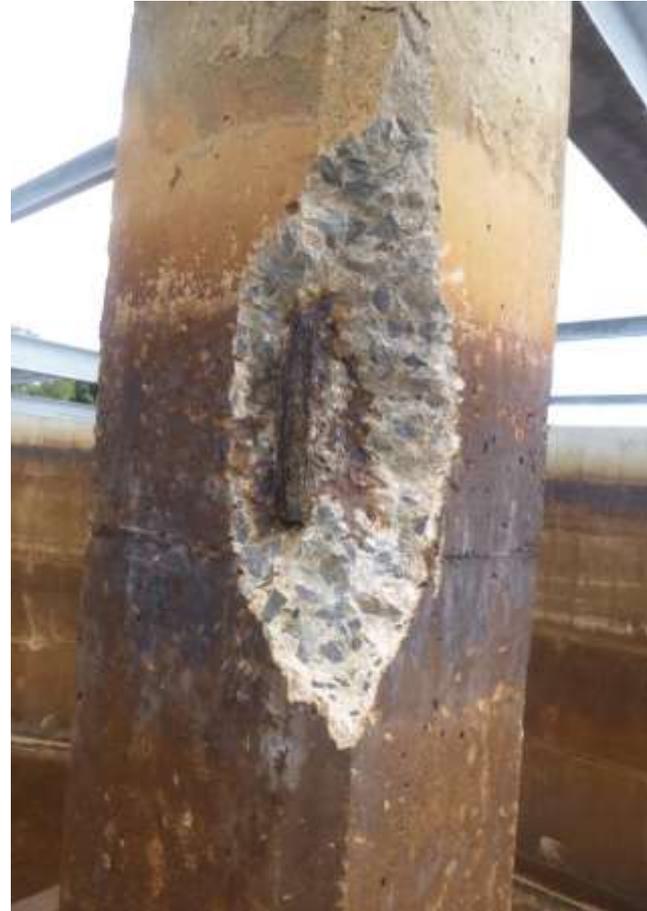
Figure 10 Top of column showing corroded reinforcement with low cover

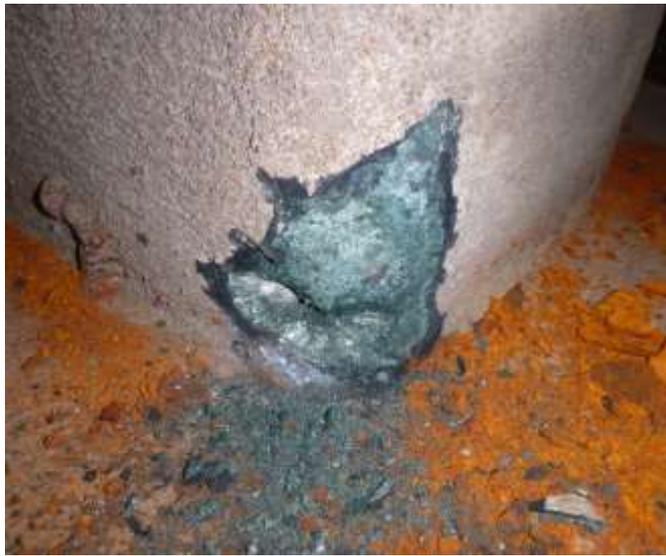
In all of the previous reports from SA Water and for the large proportion of tanks in this program, corrosion of the reinforcement in the columns below the typical water line was not reported. In reviewing tank inspection reports for all tanks for the previous 20 years, only one instance of corrosion of reinforcement below the water line in a column was reported. However, in three tanks in mid 2018 severe corrosion of reinforcement in the lower half of columns was found. Anecdotally, all of these tanks had high turnover of water (Figure 12 & 13).

Figure 12 Concrete column surface after removing rust tubercles

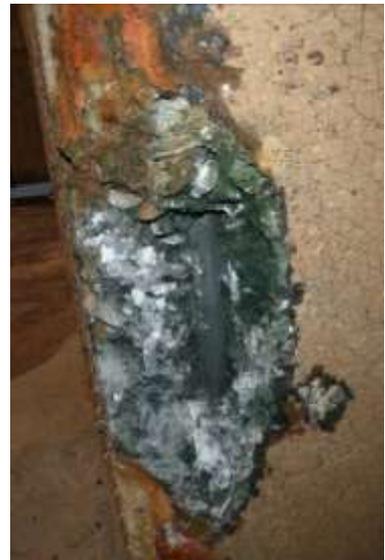
Figure 13 Exposed reinforcement at location where rust staining was evident on the column surface

Once again, the locations most prone to this type of effect were those where there was low concrete cover to the reinforcement. Clearly, carbonation is not an issue below the waterline, see Figure 15 which shows a high pH adjacent to the corroded reinforcement. The most likely cause of this corrosion is chloride ion ingress. As a result of finding this corrosion, a significant investigation has commenced in order to assess pH, chloride ion content and other parameters of the columns to confirm the mechanism.

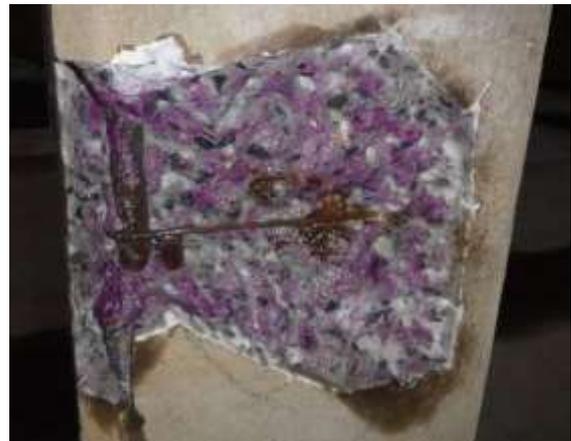
Figure 15 Concrete broken out and tested for pH with phenolphthalein

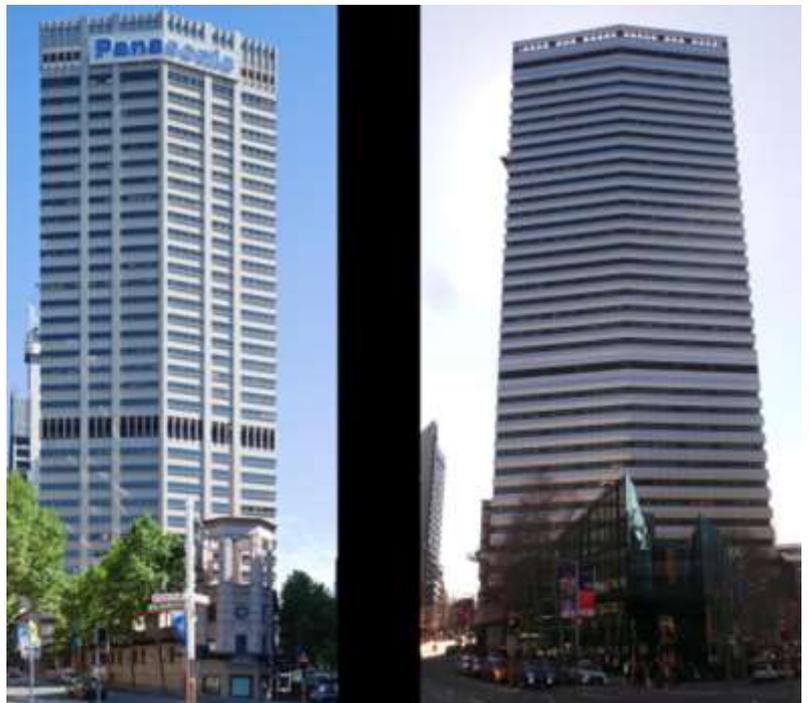
Northpoint, North Sydney - Before and After over cladding

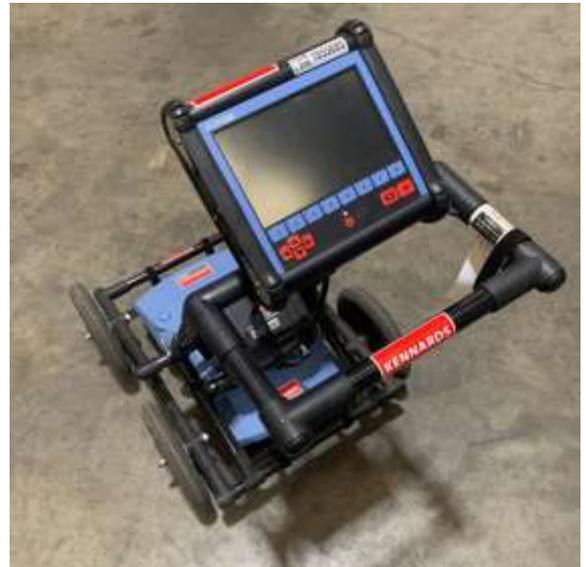
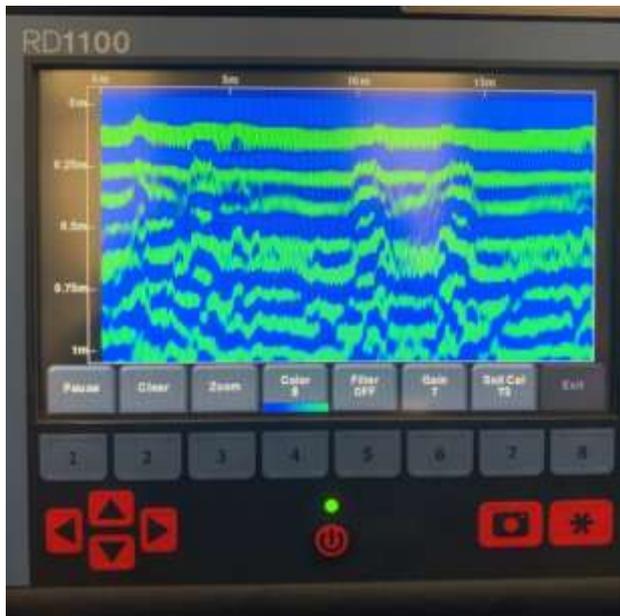
This advanced technology allows users to detect both conductive and non-conductive underground utilities using wide-band radar technology. This includes water pipes and electrical cables up to 8 metres in depth. It features an internal GPS, on-board Wi-Fi and a high-resolution touch screen.

A real benefit in using this product is the technology. It features a high-resolution touch screen that allows users to draw arrows on the screen to highlight features of interest (as seen below). Screenshots and tables can be saved as Jpg. files and emailed to colleagues using Wi-Fi. Data and images can also be exported via USB

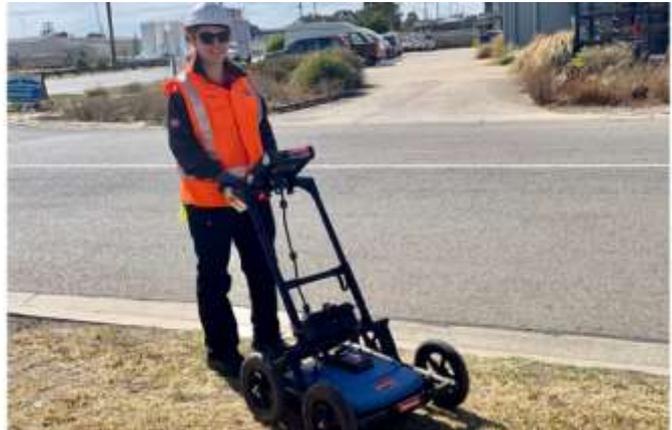
Photo: Ashleigh Woollam Test & Measure Laverton using the GPR

The Utility Ground Penetrating Radar has proven its worth in two instances. A contractor hired one of these in November 2018 for works on the water mains in Melbourne, as workers were hitting pipes not shown in the plans they had obtained. The Utility Ground Penetrating Radar found 6 additional pipes they were unaware of, thus saving the project money, time, and assisted in growing goodwill.
