Believe it or not: Hanging by the tiles!

Our first case (of believe-it-or-not consequences of cover-ups) involved a heritage building in Double Bay.

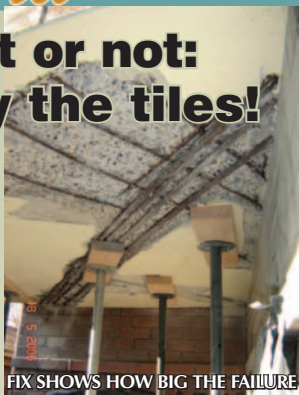
An ACRA consultant member called in to investigate found that a major cause was that **the top steel in the reo was completely corroded through** where the curved balcony met the facade.

In effect, a structure designed to span had been hanging in cantilever for who knows how long.

The balcony had been **literally hanging by the tiling.** And the tiling had been the literal “cover-up” for poor building practices that had failed to ensure adequate concrete cover to the reo. Worse was the discovery that **none of the top steel reo had survived the years in any of the balconies.**

FIX SHOWS HOW BIG THE FAILURE

They were given a less costly and disruptive option, which involved an ACRA contractor member replacing the corroded reo in the band beam and patch repairs to the slab soffit, then bonding carbon fibre reinforcement to the top surface of the slab to strengthen its cantilevered section. Membrane coatings now keep out the elements.

The repair strategy has made the balconies in this building structurally sound for many years to come.
