# WELCOME TO THE ACRA REMEDIAL INDUSTRY AWARDS 2023

# REMEDIAL CONNECTIONS

2023 AWARDS EDITION • Celebrating Excellence in Remedial Building

# REMEDIAL INDUSTRY EXCELLENCE AWARDS 2023

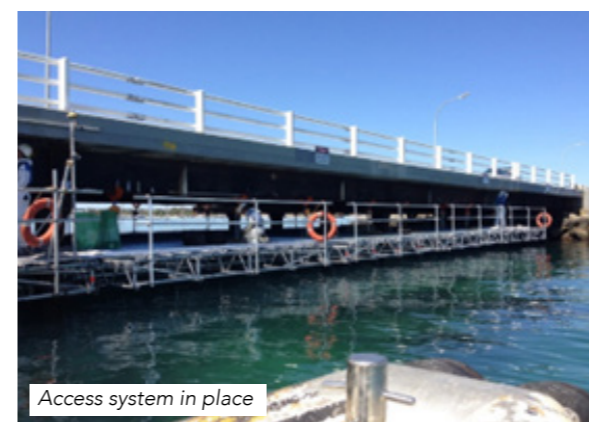
Access system in place

There is low headroom between the bridge's underdeck and the water, and over the years, this had led to accelerated deterioration and maintenance challenges. Various repair works had been conducted since the bridge's commission in 1972, albeit in a piecemeal fashion. Load restrictions had been applied due to structural deficiencies. In 2005, GHD developed a repair strategy to extend the bridge service life to 2055. This included the completion of essential repair works. In 2012, Duratec was awarded the 'Head Contract - Document and Construct' to carry out necessary repairs. The scope of works included repairs to structural steel elements, including the structure supporting the deck (beams and piles), steel

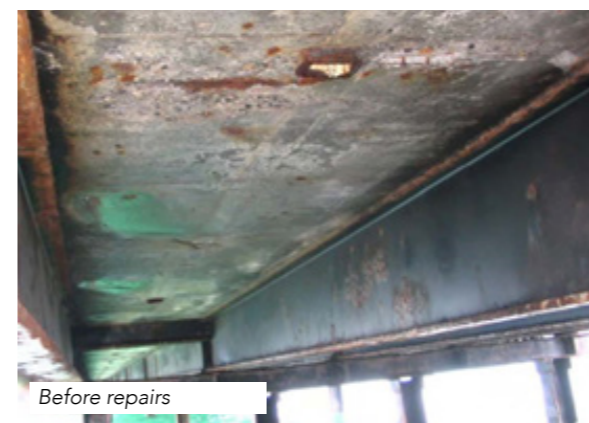
Before repairs

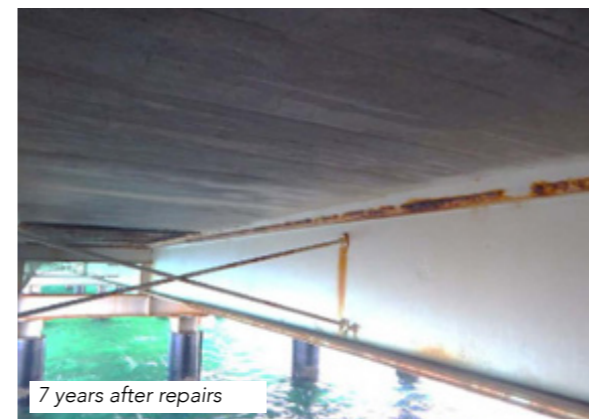
7 years after repairs

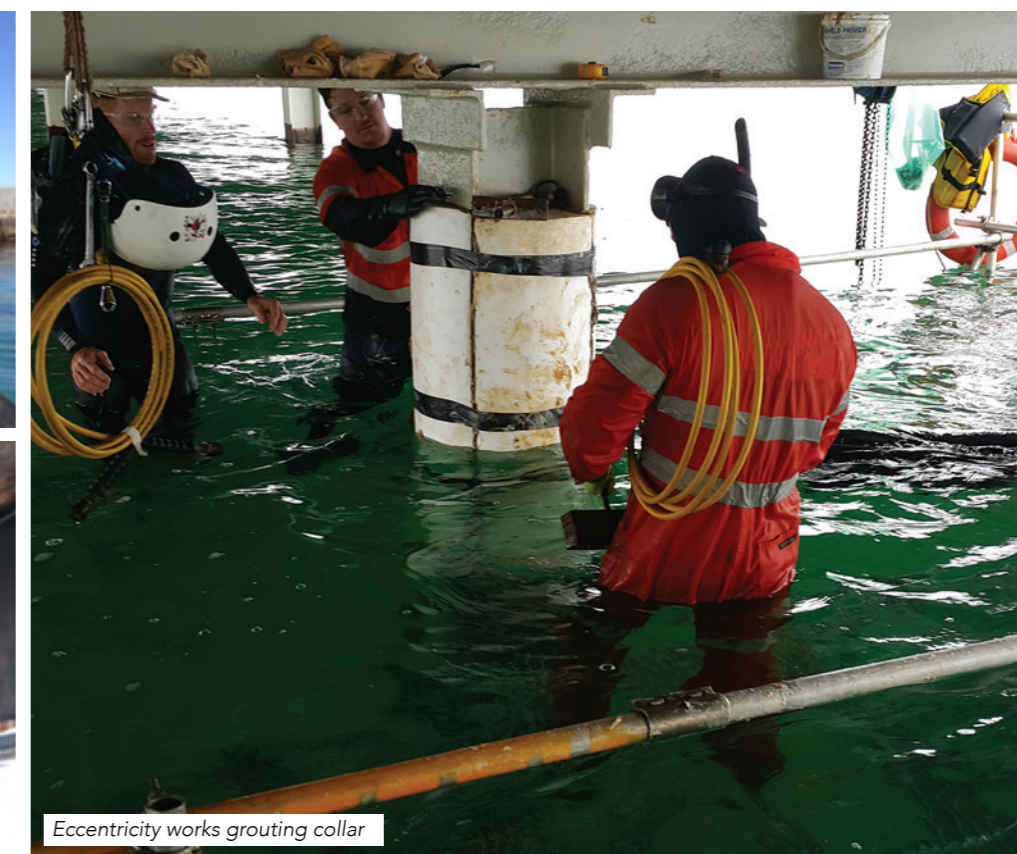
Eccentricity works grouting collar

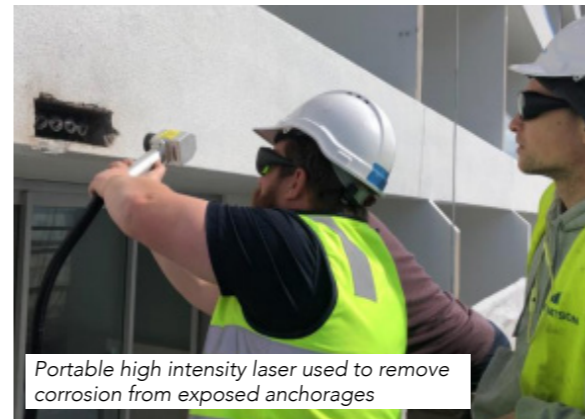
Portable high intensity laser used to remove corrosion from exposed anchorages

- Removal of corrosion from anchorages and tendons using high-intensity laser pulses to remove mortar and corrosion build up without damage.
- Effectively addressed the serious structural inadequacies that were present across the site, while also upgrading the overall appearance and aesthetics of the structure.
- Properly maintained, RM Watson's work will have extended the current design life of the structure by a minimum of 20 years, ensuring the continued operations of the popular hotel.
- Pre-project planning and close consultation with hotel management enabled the continual occupancy of newly refurbished hotel rooms across the site and the programming of key project milestones around the hotel's busy function and booking schedule.

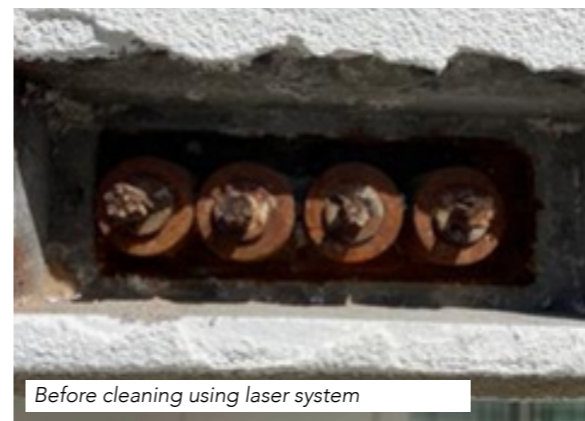
Before cleaning using laser system

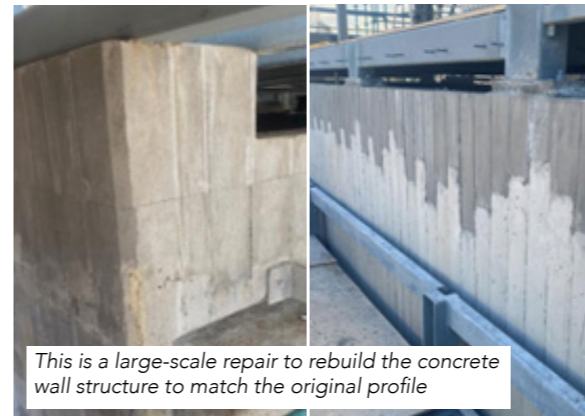
This is a large-scale repair to rebuild the concrete wall structure to match the original profile

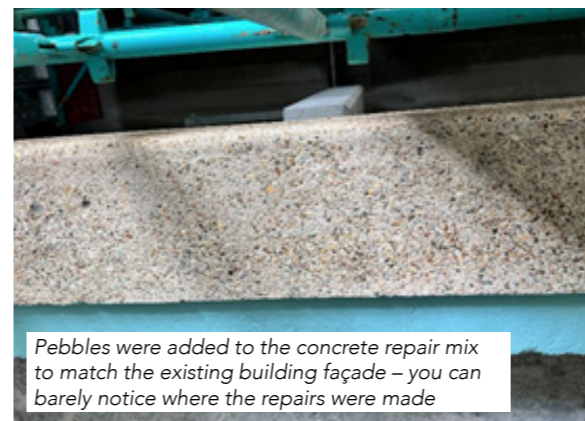
Pebbles were added to the concrete repair mix to match the existing building façade – you can barely notice where the repairs were made

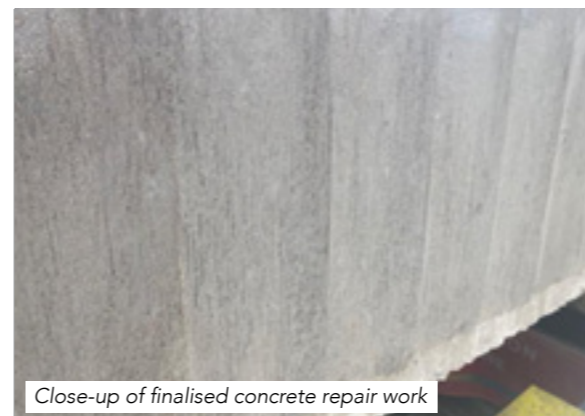
Close-up of finalised concrete repair work

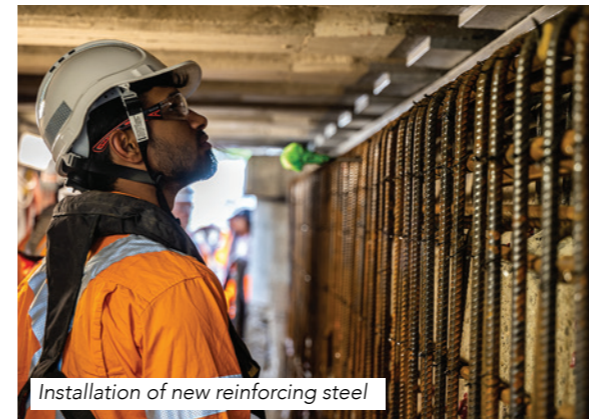
Installation of new reinforcing steel

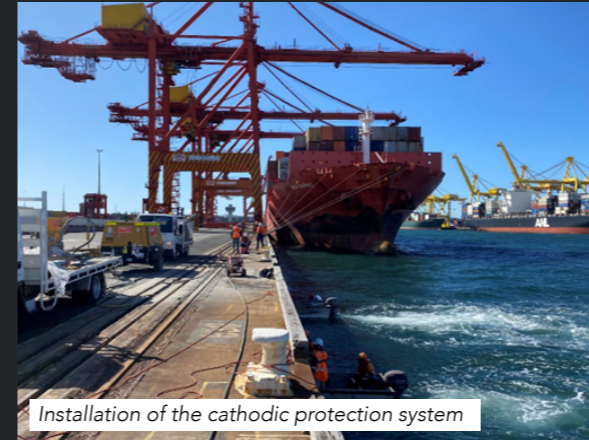
Installation of the cathodic protection system

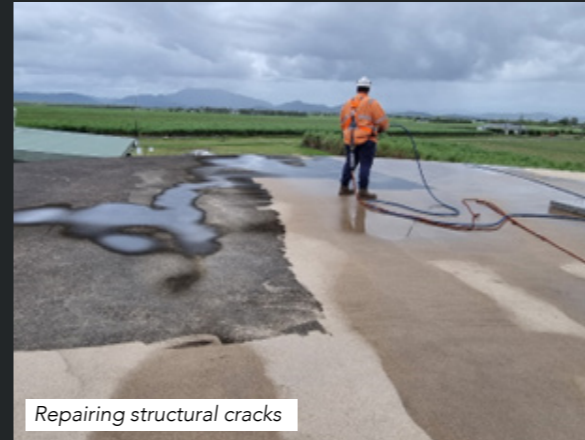
Repairing structural cracks

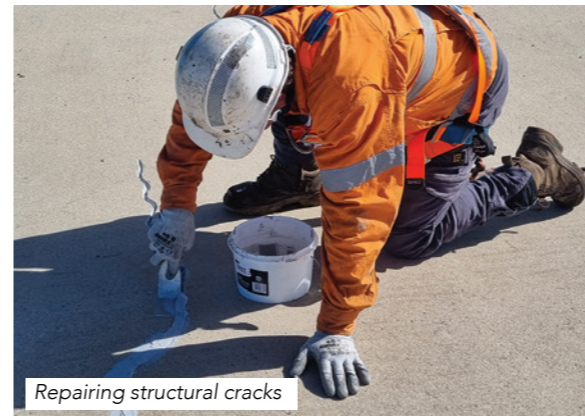
Repairing structural cracks

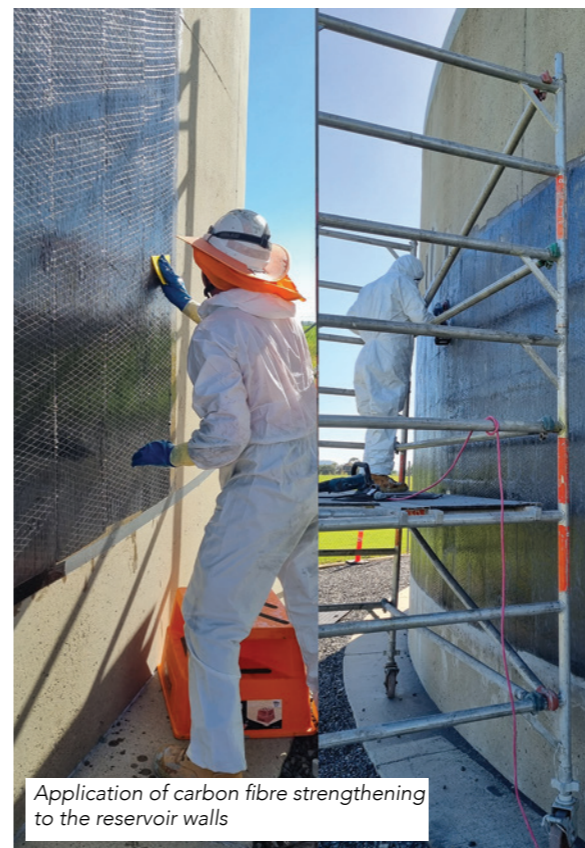
Application of carbon fibre strengthening to the reservoir walls

Freyssinet were engaged to develop a solution that allowed the reservoirs to remain in service during the repair process. The solution allowed for the repair, protection and strengthening of the concrete structure without disruption to the supply of water to the community.

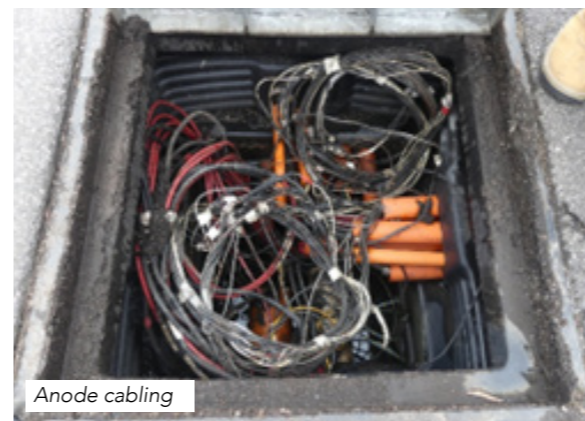
Anode cabling

- The cathodic corrosion protection system works were completed rapidly and saved on costs for the client. This was achieved with the soil anode system. Which meant only loose and laminated concrete was removed, rather than large volumes of concrete at considerable area along the bridge.
- Significant visual improvement of the bridge. The stains, spalls, and misalignments have been removed, and the bridge now looks like new. The use of cathodic protection to protect the reinforcement the amount of patch repairs required was substantially reduced.
- The project was completed on time and within budget, and the results are impressive. The Morell Bridge is now a safe, reliable, and attractive structure that will serve the community for many years to come.

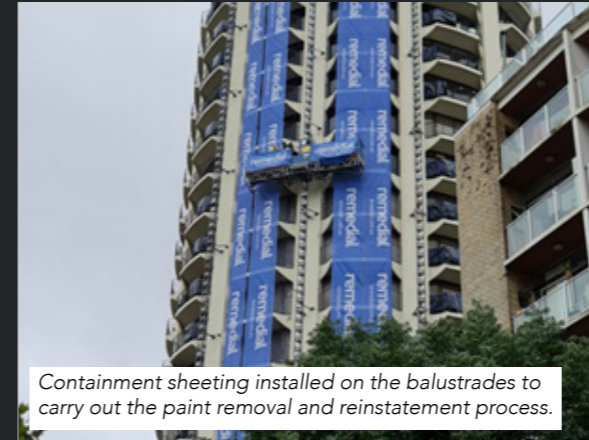
Containment sheeting installed on the balustrades to carry out the paint removal and reinstatement process.

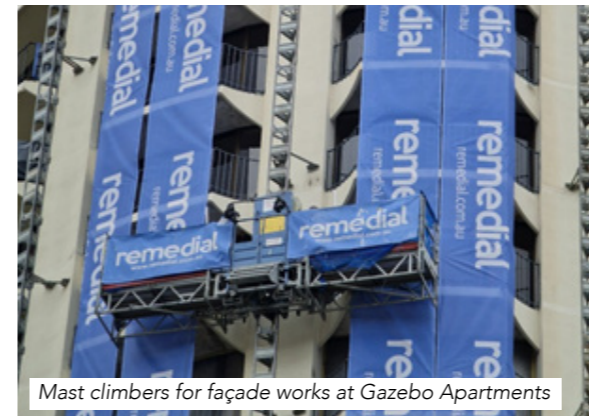
Mast climbers for façade works at Gazebo Apartments

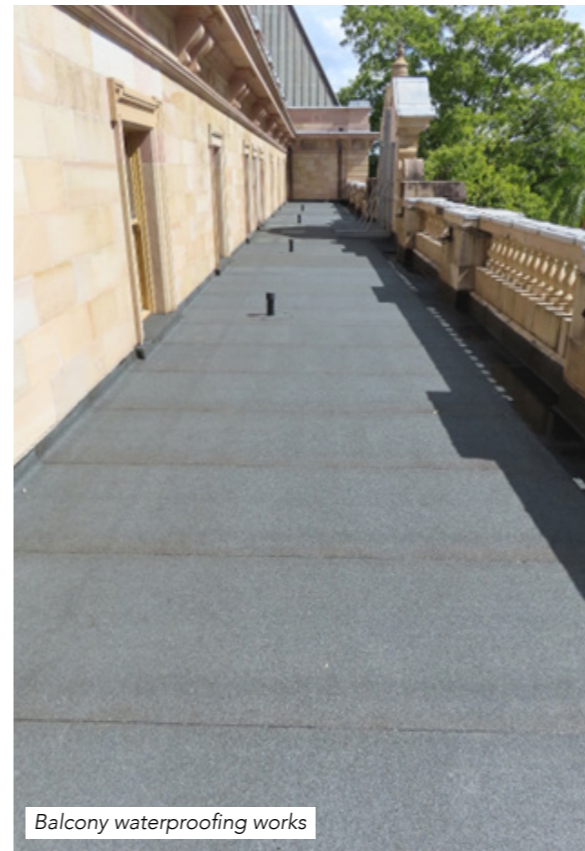
Balcony waterproofing works

Application of waterproofing membrane

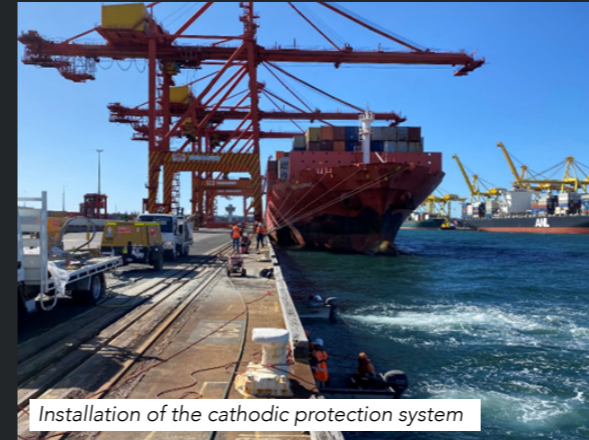
Installation of the cathodic protection system
