Remedial Building Industry

DISCUSSION PAPER

The DBPA and Implications for Waterproofing of Class 2 Buildings

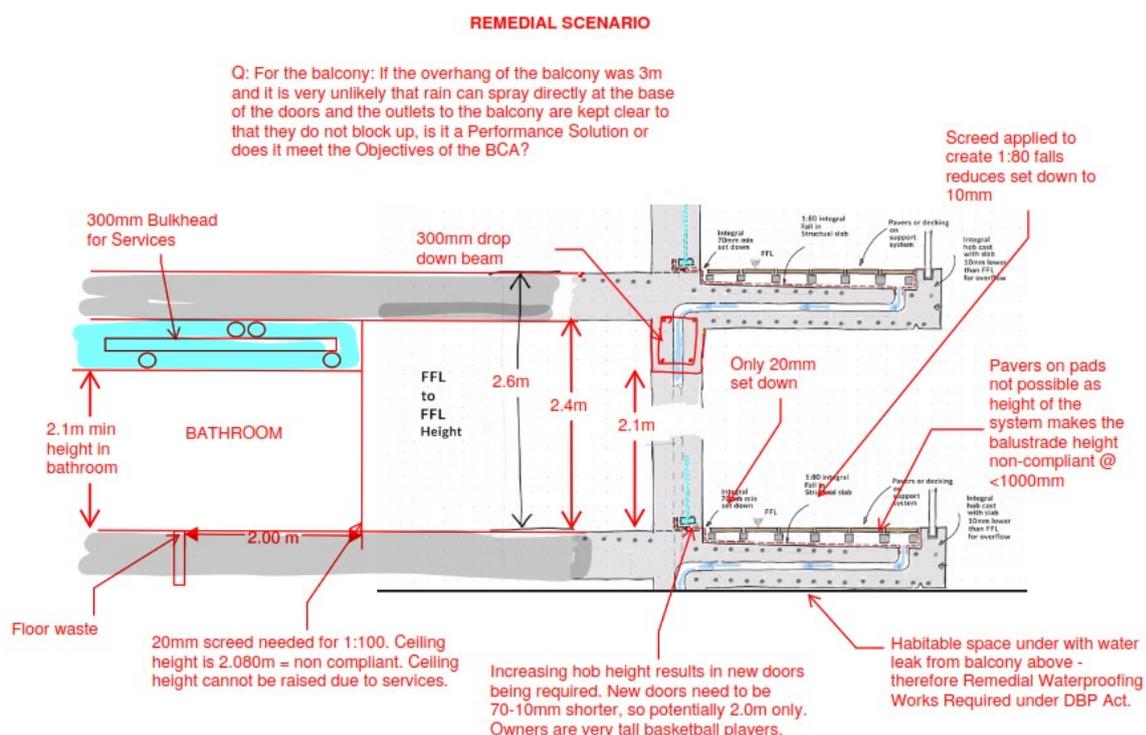
A few of the potential issues are outlined in the following sketch, incorporating the conflicting elements:

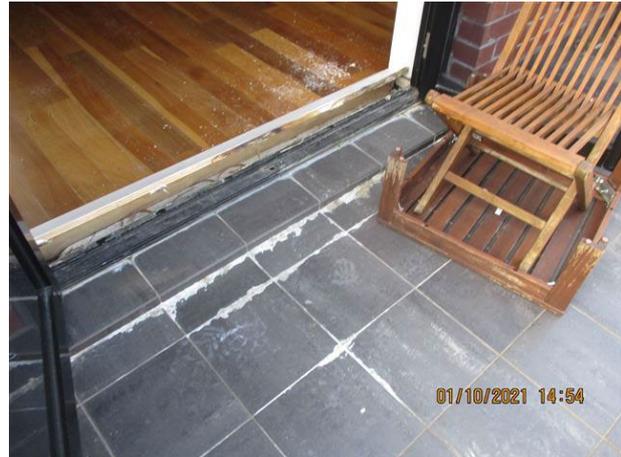
An apartment block, converted from a hotel, has water penetration issues originating from the balconies. Historically, in addressing the failed waterproofing the replacement balcony waterproofing was applied as liquid membrane on top of the pre-existing tiles; there is no cavity flashing; and potentially the hob is not to BCA standard.

The remedial solution is to demolish the tiles, re-screed and re-waterproof with new cavity flashings. The upturn of the waterproofing may not meet the 50mm above tile level requirement. The remedial solution addresses the water penetration issues and would cost approximately \$20,000 - \$30,000 per balcony [the cost varies according to balcony size].

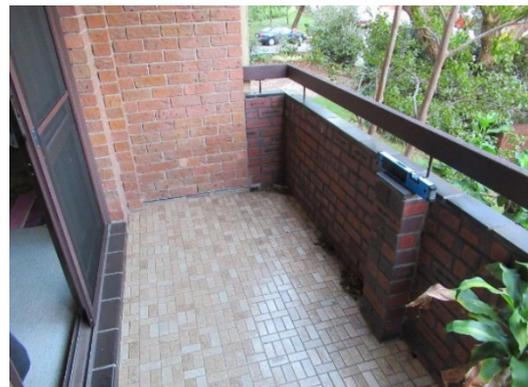
Long term issue of water ingress via the slab into occupied apartments below. The Owners’ Corporation has limited funds and 18 small balconies to remediate. The balconies are tiled and have a single skin unreinforced masonry balustrade. The balustrade cannot be certified as structurally adequate to current AS1170.1 requirements (photo opposite).

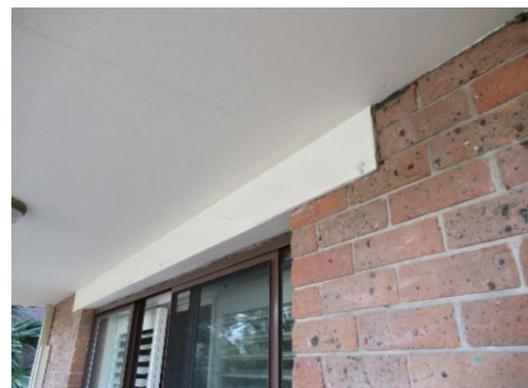
At the door threshold, the step down is minimal. The door head is hard against the slab drop beam (photo below).

Detailing of the membrane upturn has been scoped to turn up the inside face of brickwork only.

Falls will be corrected, and new internal wastes provided to manage nuisance water at the perimeter, replacing original lateral outlets. While reinstating the existing sliding doors, an increased angle will be provided for membrane termination, but at a finished height below the required Termination Height for the locality.

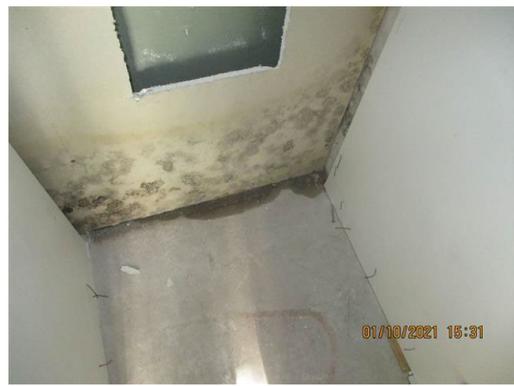
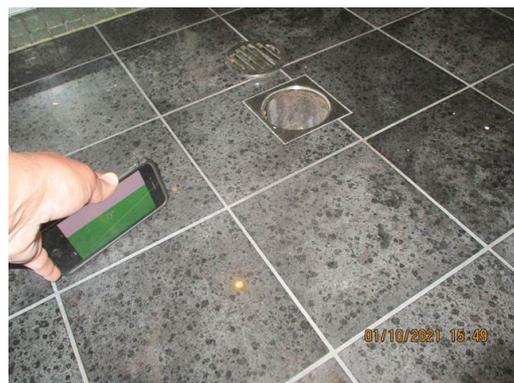
An Owners' Corporation has multiple bathrooms with leaking shower recesses, causing significant mould build up in impacted areas (photo opposite).

Floor ceiling heights throughout the apartments meet the BCA **minimum** requirements. There are no falls to the bathroom drainage outlets. To meet the required falls, screed is required. The application of the screed may result in the ceiling height being too low and not meeting BCA requirements.
